REFERENCE NUMBER: HMT-0109-00-E

SUBJECT: Hydro Mobile F100, F200 & F300 series shock absorber lower pivot recall

SUBJECT: Replacement of shock absorber lower pivot

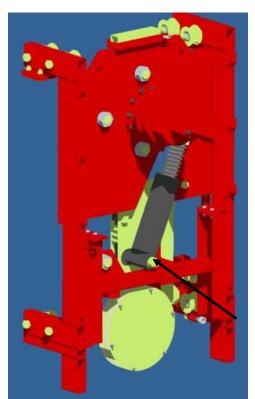
3. Punch the shaft and nut to lock the nut on the lower pivot shaft. Using a zip gun facilitates this step.

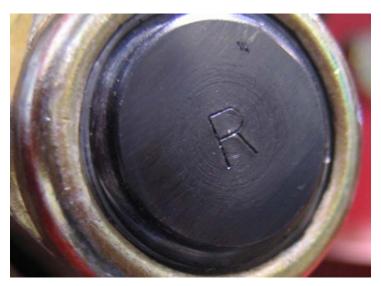
New revision of lower pivots are stamped with the letter **R** at one end. It is also important to note that the threads at each end are of different length. The **R** marking is always on the side with the longest thread.

- 1. Twist the shock absorber to insert the new lower pivot in the lower mounting sleeve.
- 2. Apply grease to the lower pivot and insert it into the shock absorber with the end with the R marking (longest thread) facing outward, away from the brake box.
- 3. Align the lower pivot with the brake box and screw the lower pivot into the brake box (using the installation sleeve and nut).
- 4. Insert the lower pivot completely and make sure it is completely screwed into the brake box using a 1 ½" wrench.
